TEST REPORT NO.: 418700-01-04-R23-0088

SUBJECT: FREIGHT CONTAINER MECHANICAL SEAL CLASSIFICATION TESTING
PER ISO 17712:2013 (E) CLAUSE 5,
CONDUCTED ON 25 BARRIER SEALS, MODEL NO. BLOCKBAR,
SERIAL NOS. 0002246 THROUGH 0002270

SEAL CLASSIFICATION: HIGH SECURITY

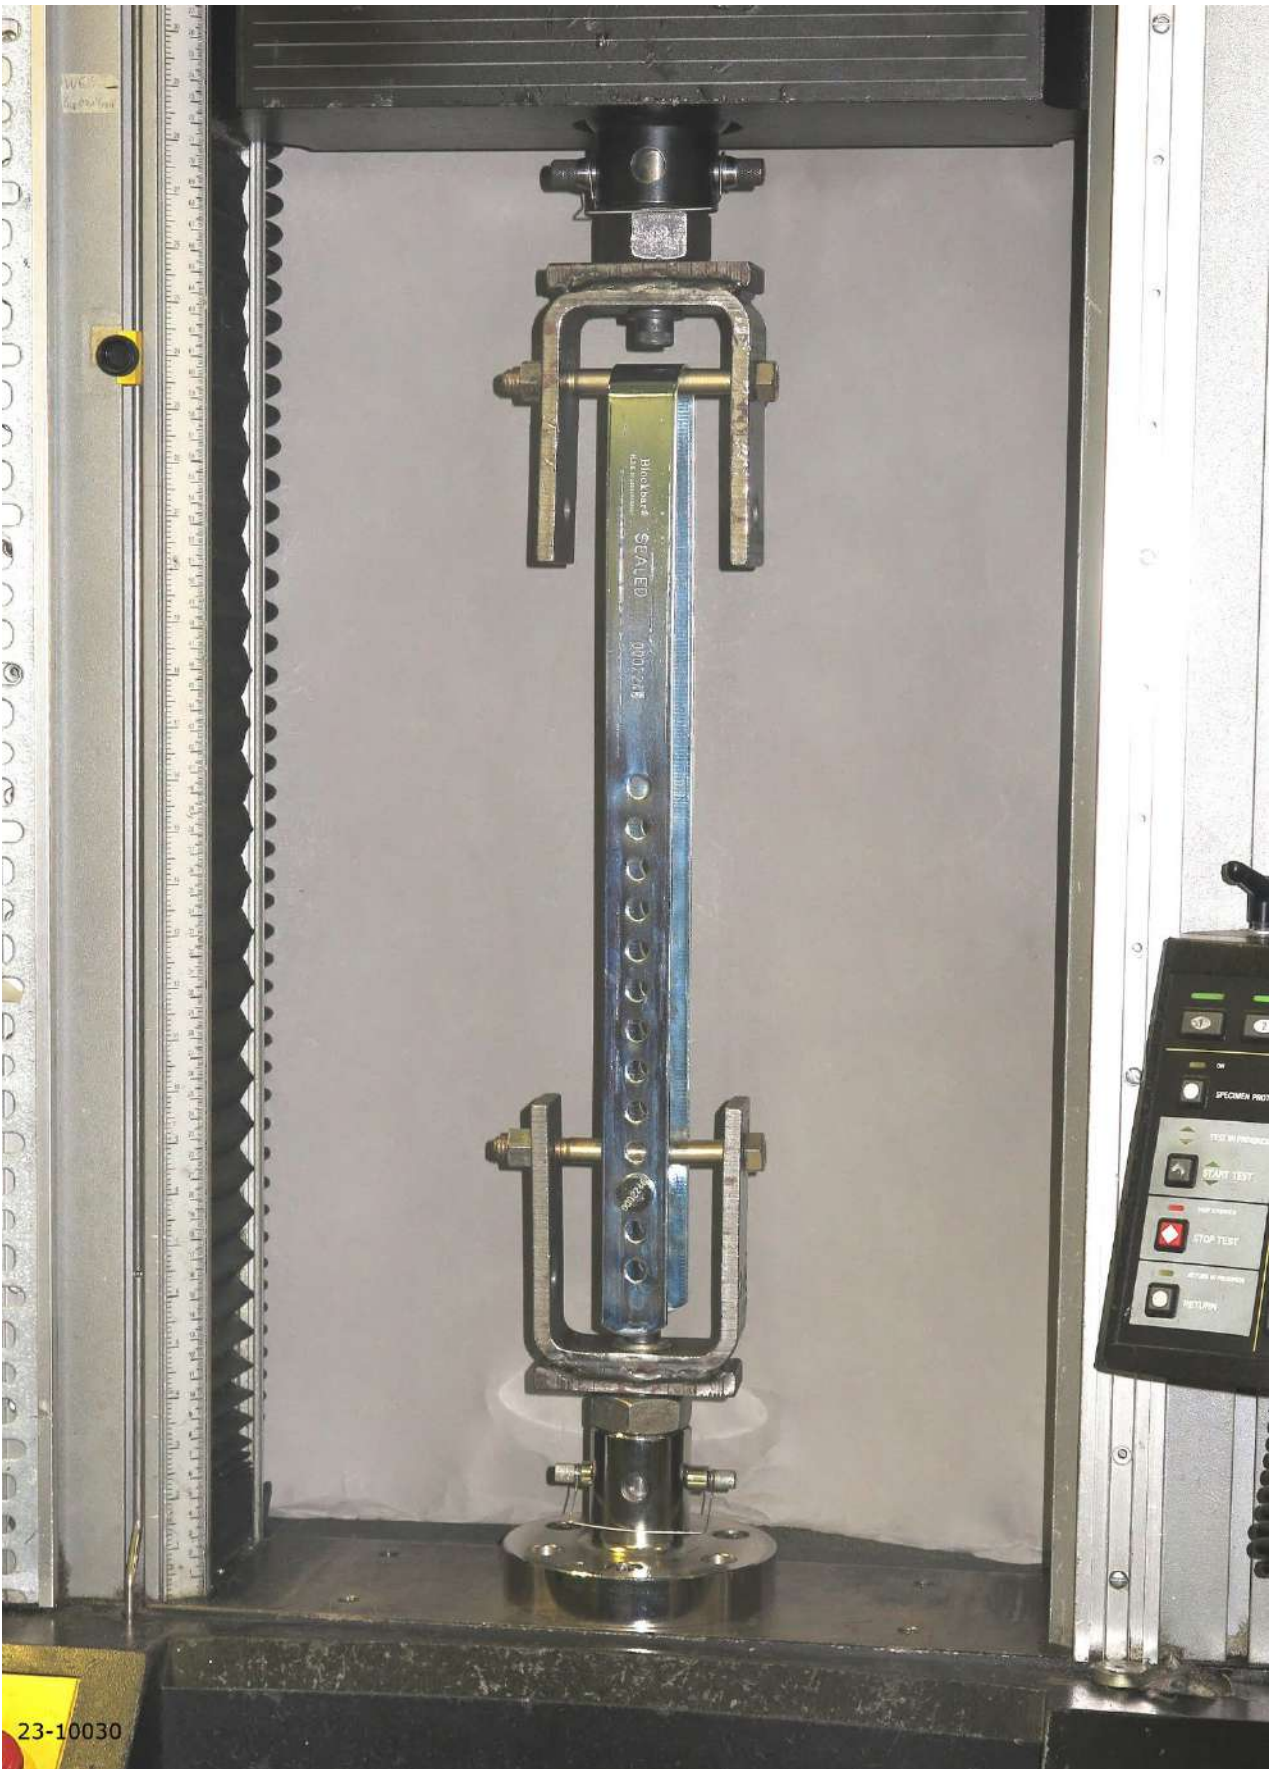
30 JANUARY 2023
FILE NO. 23-10030

TYPICAL PHOTO OF THE TENSILE TEST SETUP

A pretest visual inspection of the test items revealed no anomalies.
All testing was performed in accordance with the referenced specification.
The pulling speed during the test was 50.8 mm/min.
Test room ambient conditions: 20.8° C and 59.9% RH

* A post-test visual inspection of the test item revealed that the rear fork broke at the lock pin due to testing.

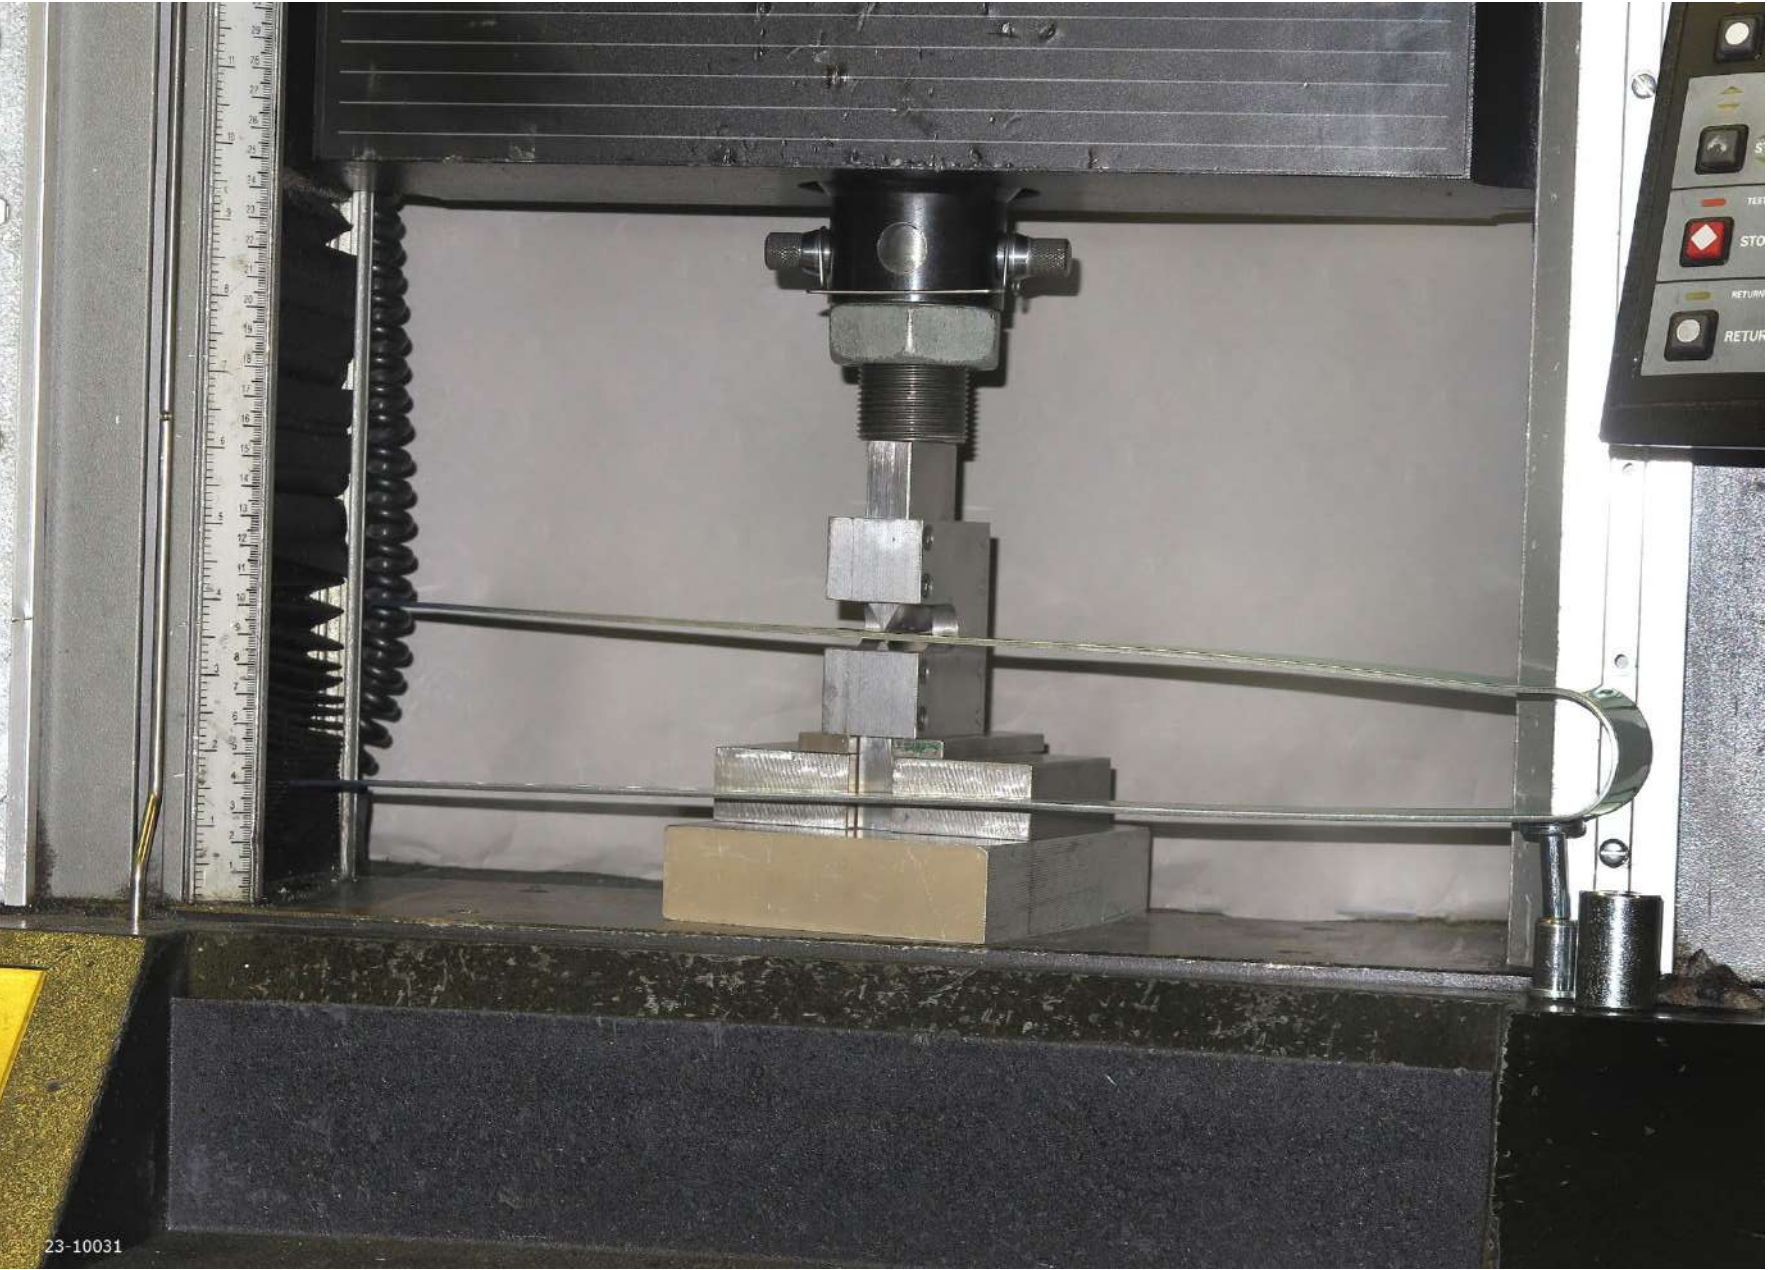
31 JANUARY 2023
FILE NO. 23-10031

TYPICAL PHOTO OF THE SHEAR TEST SETUP

The travel rate during the test was 12.5 mm/min.

* A post-test visual inspection of the test item revealed that the cutting blades severed the bar of the seal due to testing.

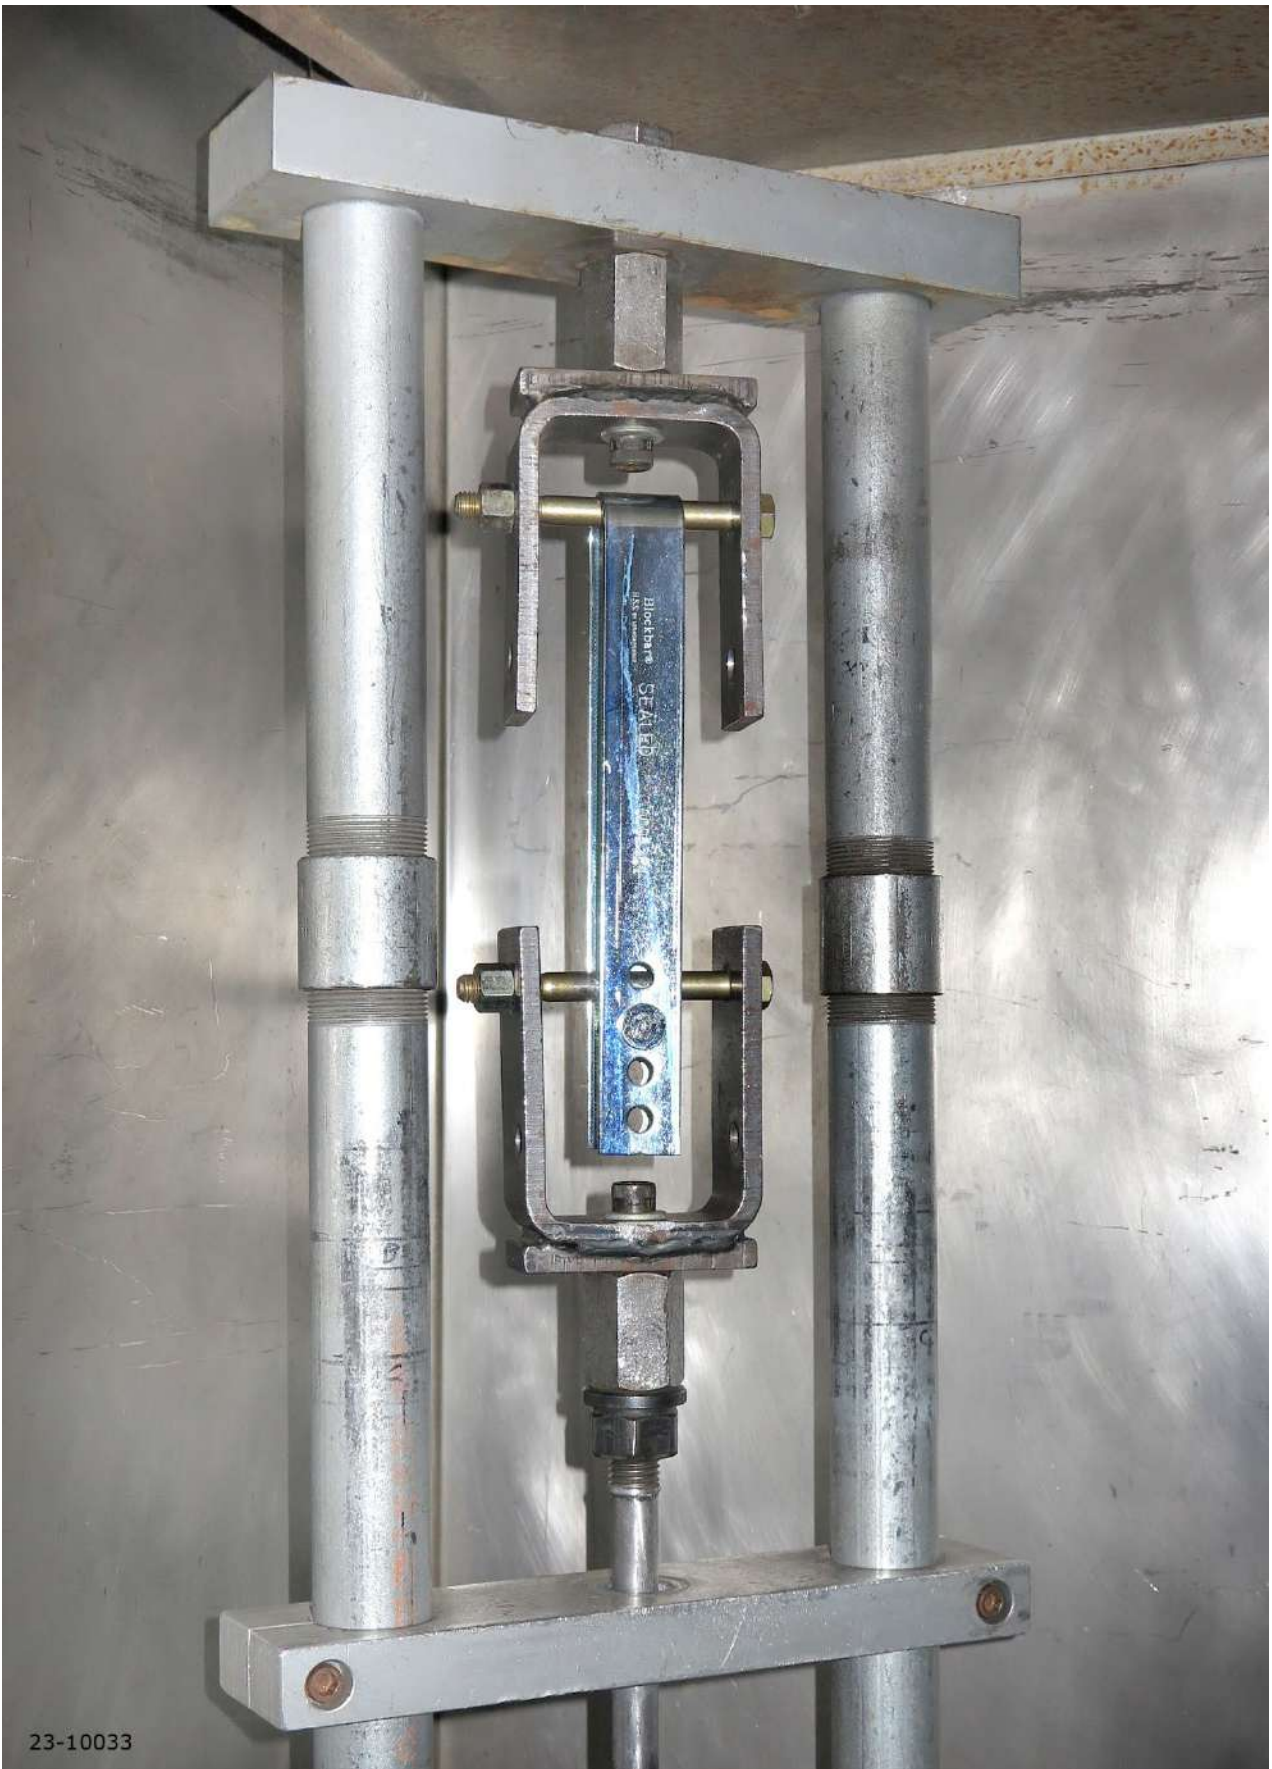
30 JANUARY 2023
FILE NO. 23-10033

TYPICAL PHOTO OF THE IMPACT TEST SETUP

A pretest visual inspection of the test items revealed no anomalies.
All testing was performed in accordance with the referenced specification.
Nonfunctional portions of the seal were removed in order to fit into the fixture.
Test chamber conditions: 17.6° C and 49.2% RH

* A post-test visual inspection of the test item revealed that portions of the seal broke or deformed due to testing. The cable and lock of the seal remained intact.

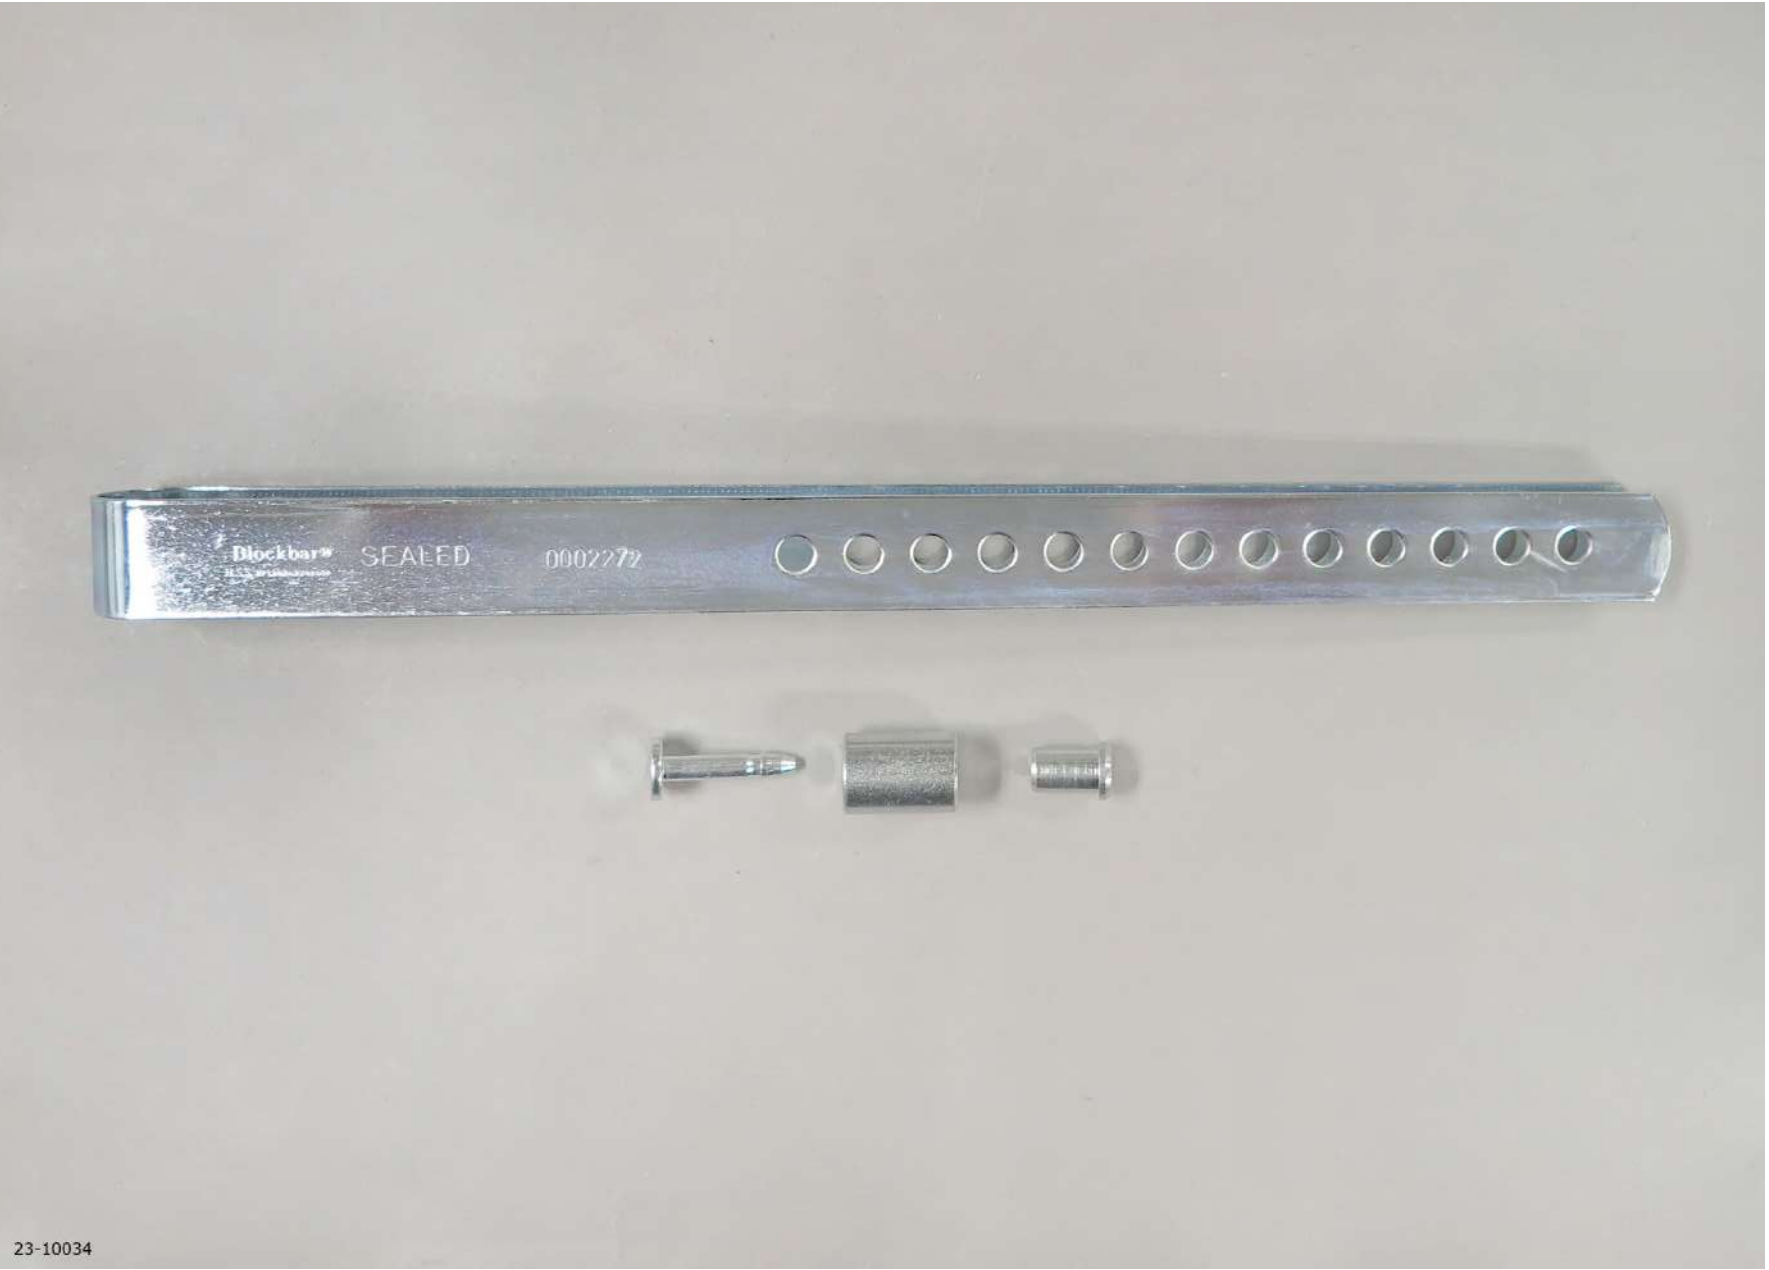
30 JANUARY 2023
FILE NO. 23-10034

MODEL NO. BLOCKBAR BARRIER SEAL
